New firmware release MR3 is available

For HP Stitch S1000 126i Printer Series

November 2020

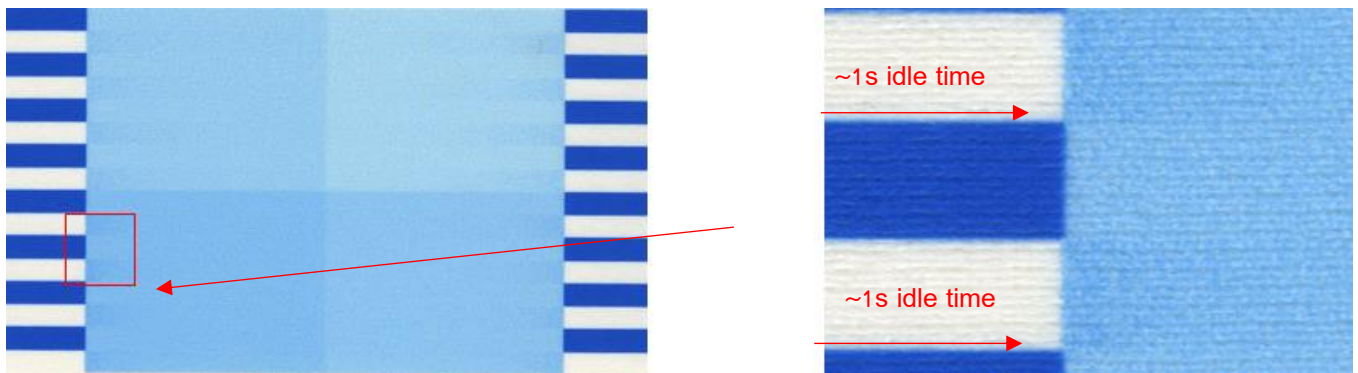
Dye Enrichment is an ink-related defect that gradually appears after a short idle period (>1sec). An increased colorant density in individual drops is observed and the image on the substrate appears darker.

Example of image quality defects due to Dye Enrichment

This defect decreases quickly after few centimeters of printing. The Dye Enrichment Correction functionality is able to mitigate this local defect and improve the final printing quality.

TIP: Spit Bars could also be used to reduce the idle time for all colors, and as such, using Spit Bars will help to reduce the Dye Enrichment effect.

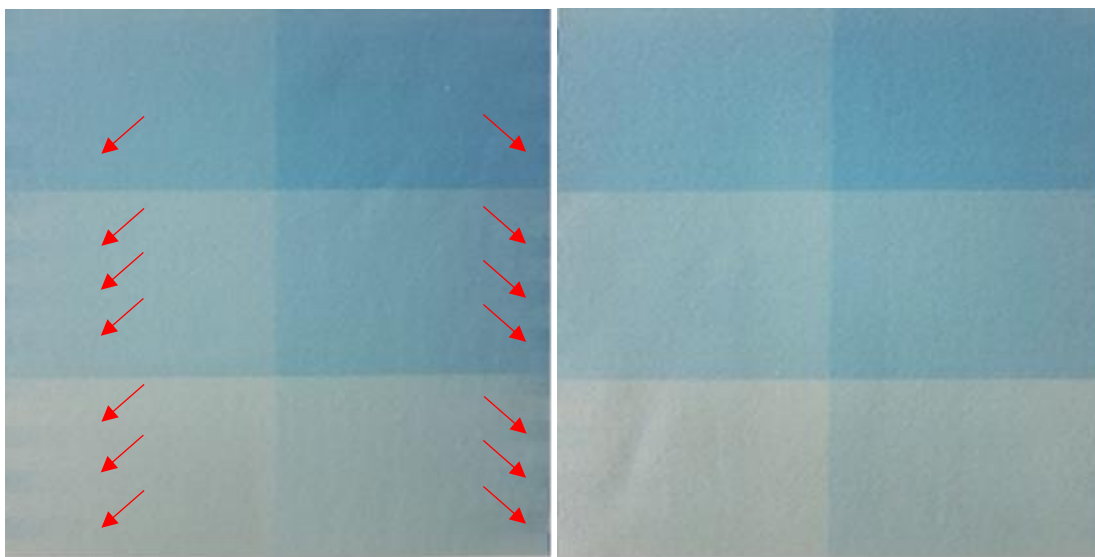
Results of Dye Enrichment validation plot with idle time (Left: without algorithm; Right: with algorithm)

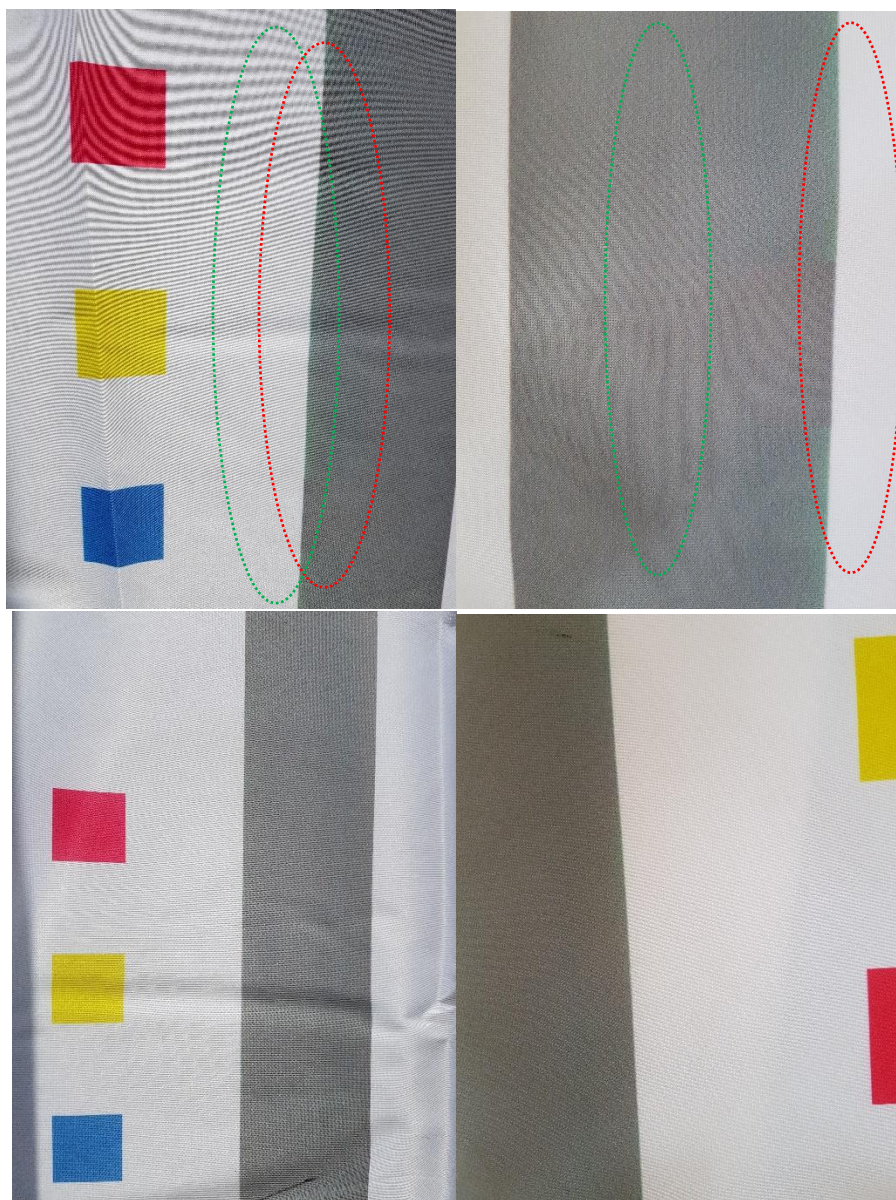
Dye Enrichment results in user plot (Top: without algorithm, Bottom: with algorithm)
