# Firmware NEXUS\_01\_18\_11.1 is available

## For HP Latex 3x0 Printer Series

June 2021

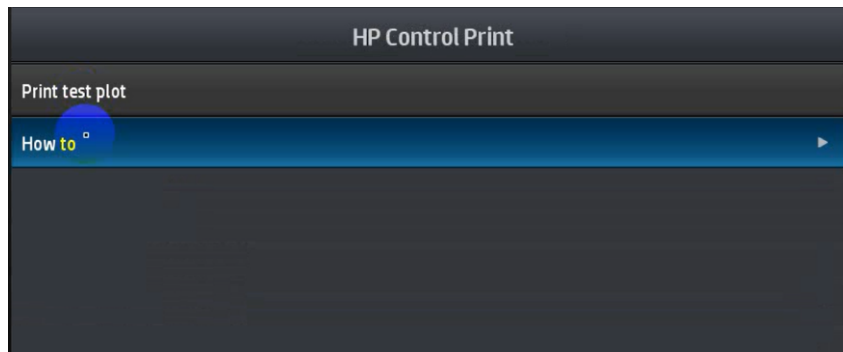
3. Fixes and improvements to the HP Control Print Plot.

Troubleshooting instructions have been integrated in the printer's front panel (**Settings > Image-quality maintenance > HP Control Print > How to**) to help guide the user on how to detect and fix image quality issues using the HP Control Print Plot.
