How to solve 3L ink cartridge rejection issues

This document provides recommended troubleshooting actions for issues where 3L ink is rejected or not accepted by the printer.

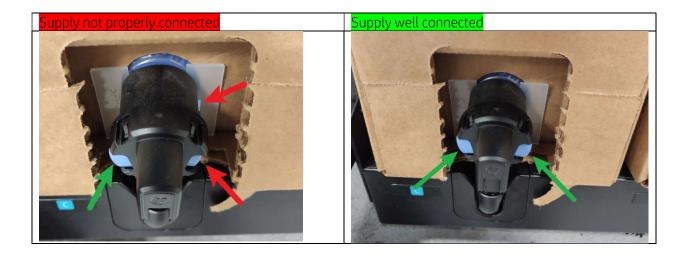
Check that the supply ink connector is properly inserted.

The supply ink connector has two blue levers. These levers should be latched to the 3L supply, otherwise the printer will report "Supply not Connected".

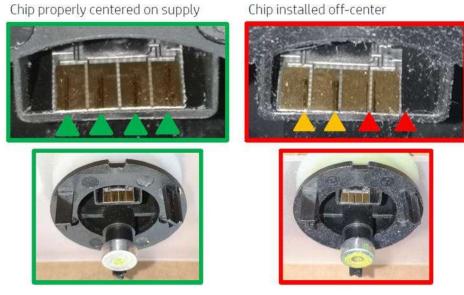
See the following example of a misplaced chip. As a result, the connector is unable to contact and therefore communicate with the acumen.
