Firmware PLS_31_22_14.6 is available

For the HP Latex 700 / 800 printer series

June 2022

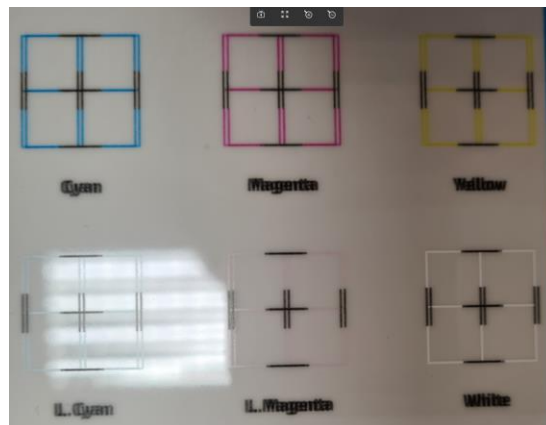
With the previous firmware the printer lost color alignment after performing the white manual alignment, the new firmware fixes this issue.
