New firmware release

GEMINI_09_23_55.1

For the HP Latex 2700 printer series

April 2024

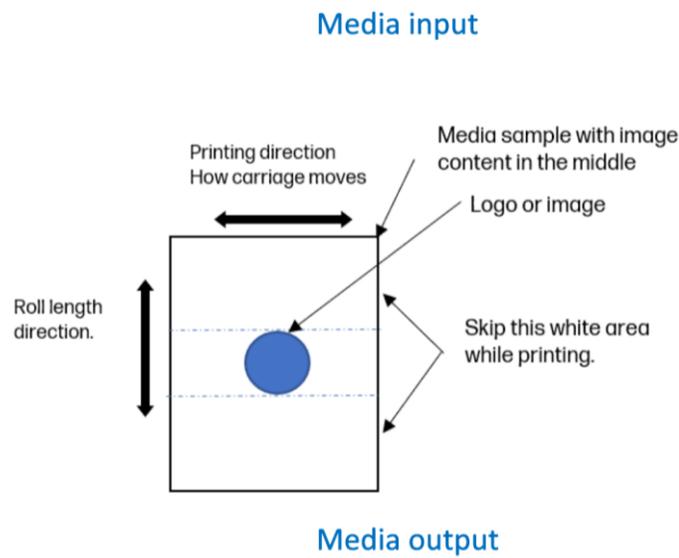
- **Skip white areas**

While printing in color or white modes, the printer will automatically advance the media if there is a large area where there is nothing to print. For example, if there is a big gap between jobs, the printer will advance the media to start printing the next job faster.

This feature needs to be activated through the user diagnostic 99925 *Enable or disable Skip Empty Areas*. The printer will automatically analyze the jobs to be printed and detect if there is any space between jobs that are big enough to allow the media to move faster. For the printer to be able to activate this feature, there cannot be any pixel printable in the empty area.

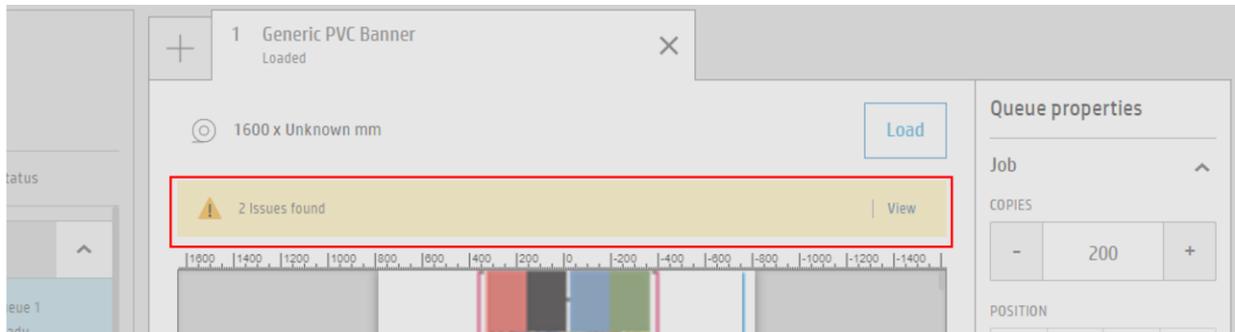
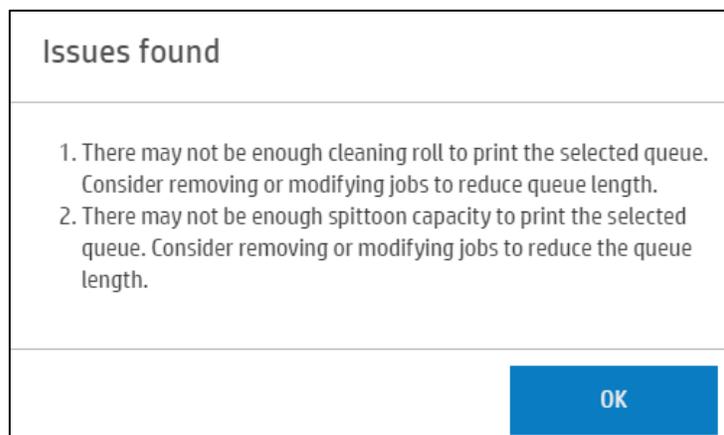
When adding a job in the jobs queue, the IPS will inform customers if there is enough web wipe roll and left Spittoon capacity to complete the selected jobs. The following error message is displayed if there is not enough cleaning roll or left Spittoon to complete the queue:

If the user wants to print anyway, the printing will automatically stop when one of these consumables reaches its life end.

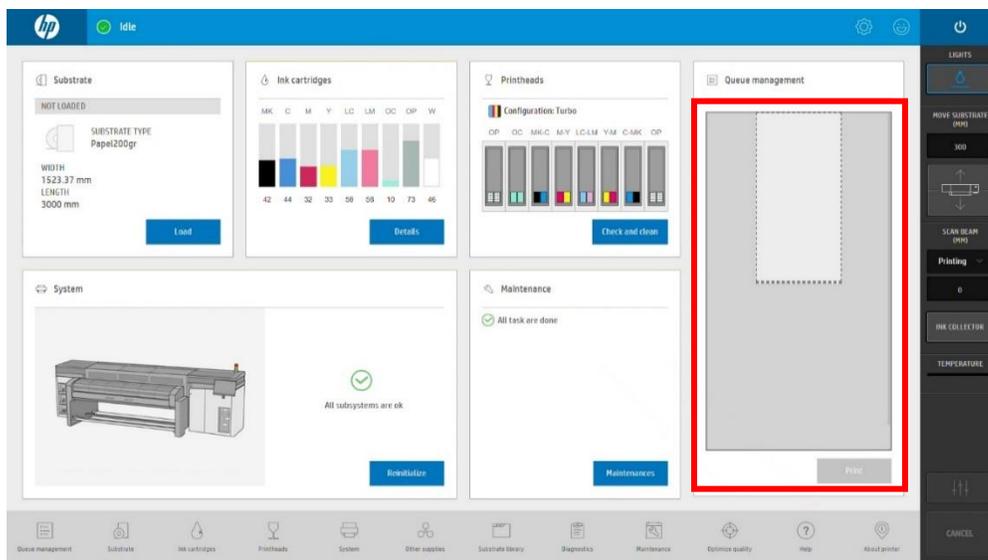
- In the Internal Print Server (IPS), the queue management preview might show a random bug where the image glitches for one second moving a little to one side and goes back to normal. This happens randomly and not very often. The issue doesn't affect the behavior of the application. It can happen in the main view of the IPS or in the Queue management window.
