New firmware release

GEMINI_09_24_19.3

For the HP Latex 2700 printer series

June 2024

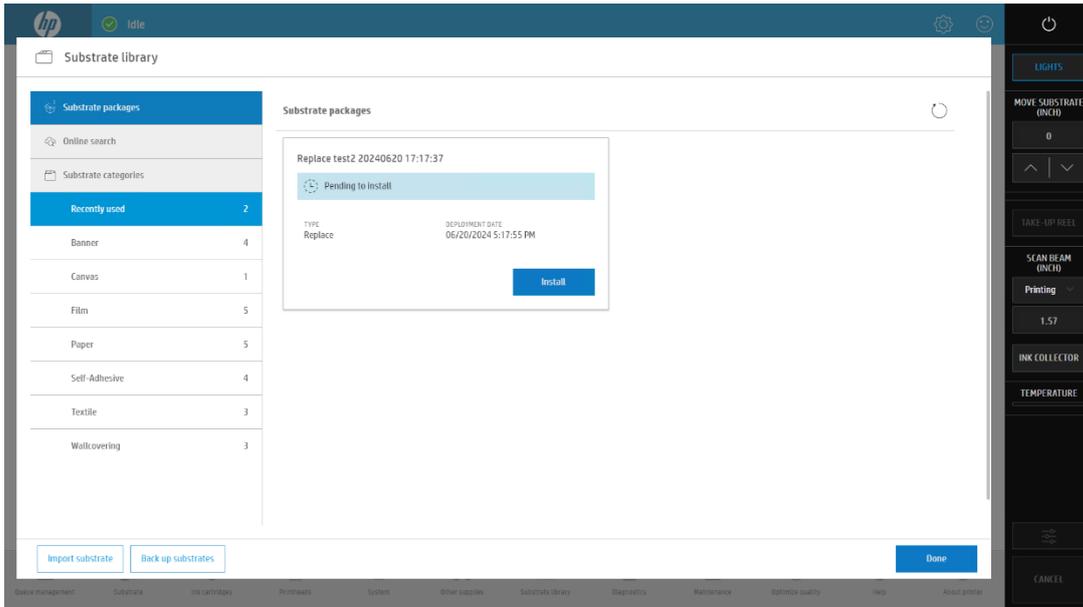
Occasionally, when attempting to replace the substrate packages using the backup from the Configuration Center, an error may occur in the process.

1. Generate a Replace package in Configuration Center.
2. Download and try to Install the Replace package in IPS front panel.

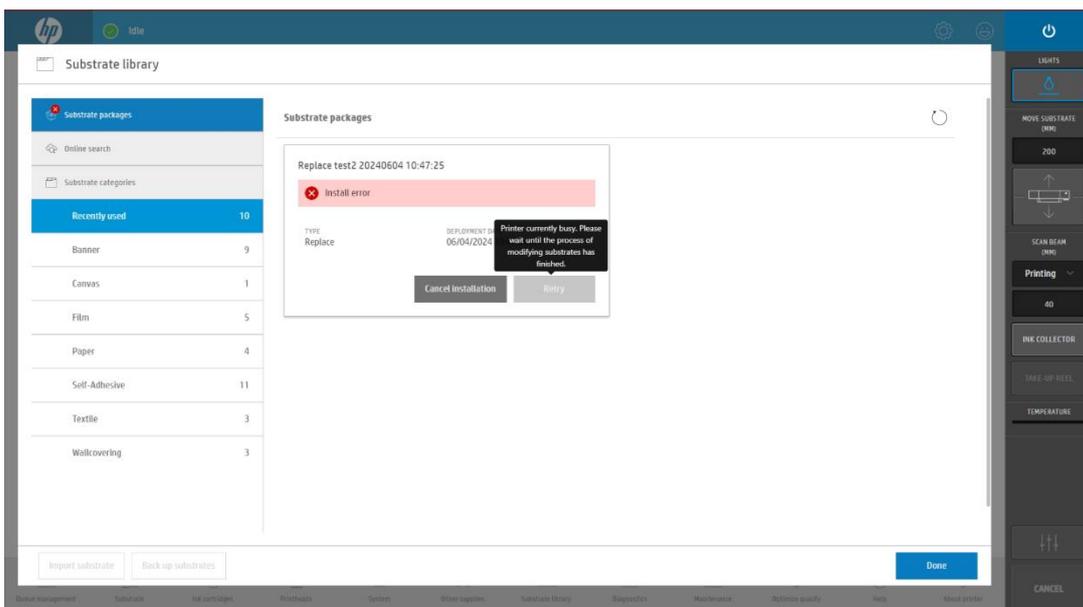
3. The Backup is done, but the "Option not available. During ..." error is displayed.
4. Tap on Retry button for try to install again the Replace package.

5. Some seconds later, the "Substrate package XXX failed ..." error is displayed.
6. Tap on Retry button again.

7. The Custom Medias are deleted, but the Replace package is in "Installing" status and the "Receiving" status is displayed all time in the right bar.

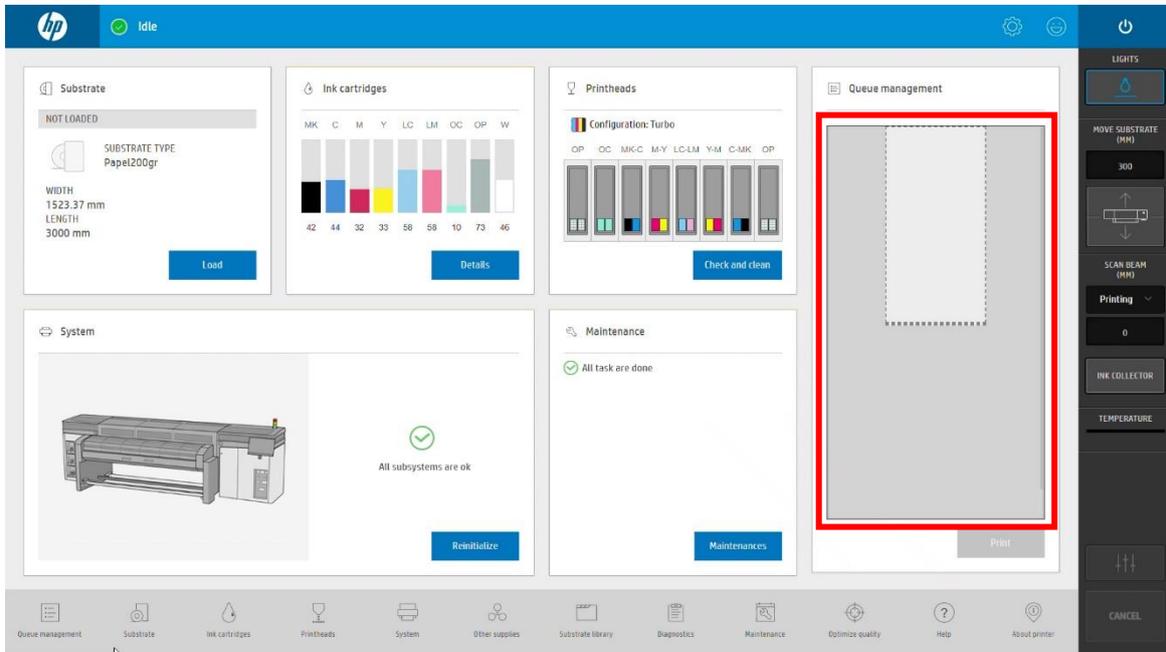
- **Queue management preview may show media moving.**

The queue management preview might show a random bug where the image glitches for one second moving a little to one side and goes back to normal. This happens randomly and not very often. The issue doesn't affect the behavior of the application. It can happen in the main view of the IPS or in the Queue management window.
