New firmware release

GART_11_24_45.2

For the HP Latex 2700 and FS Printer Series

March 2025

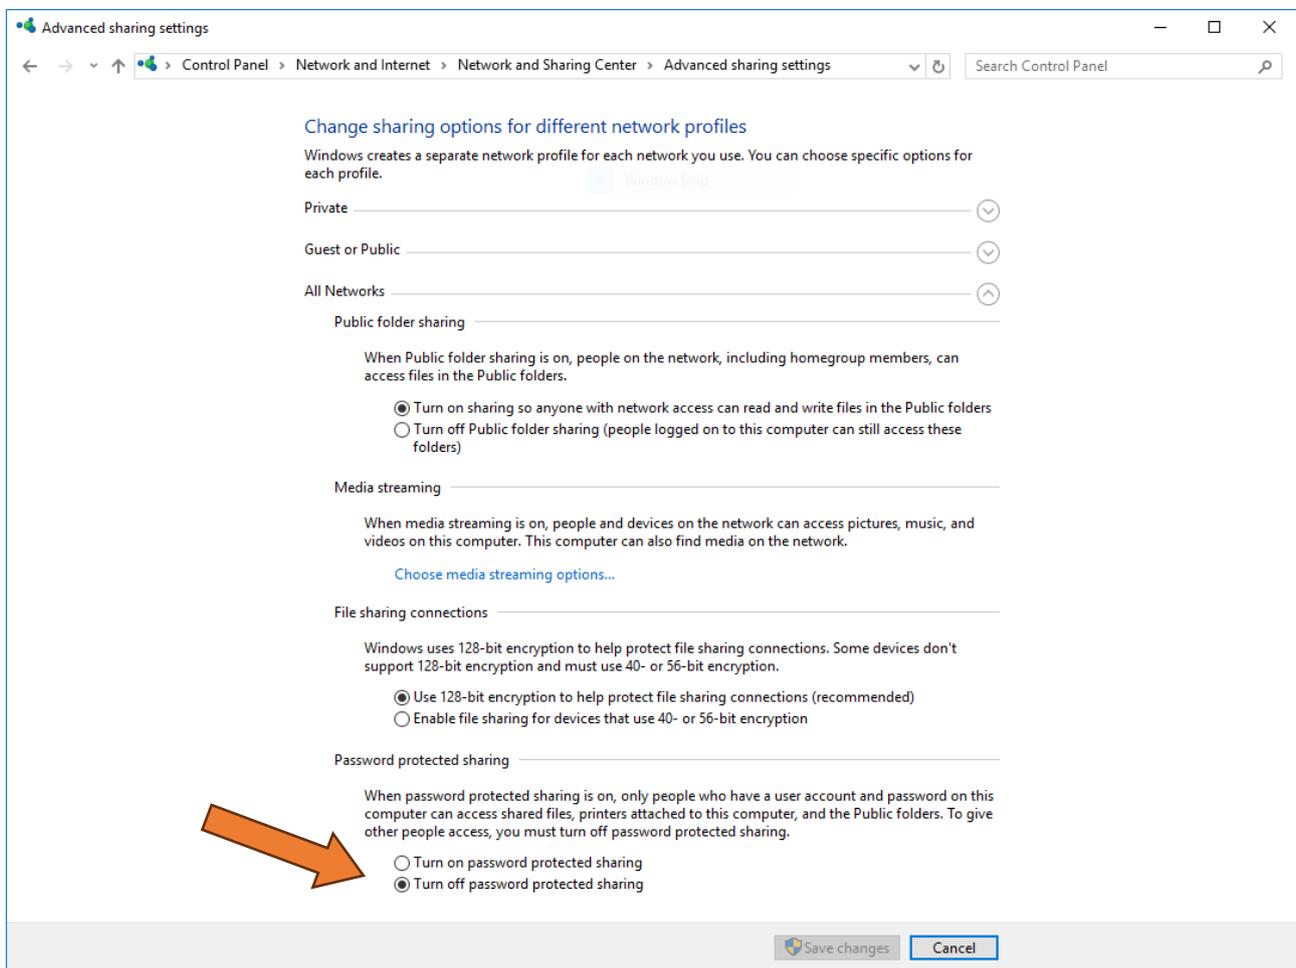
- **Password protected sharing**

A bug in the previous firmware versions altered a specific Windows setting known as “**Password protected sharing**”. When this setting is enabled, the connection between the RIP station and the Printer may be disrupted. To solve this issue, enter the following directory on Control Panel:

Control Panel > Network and Internet > Network and Sharing Center > Advanced sharing settings

And select “Turn off password protected sharing”:
