# How to solve 3L ink cartridge rejection issues

## HP Latex 700 and 800 Printer Series

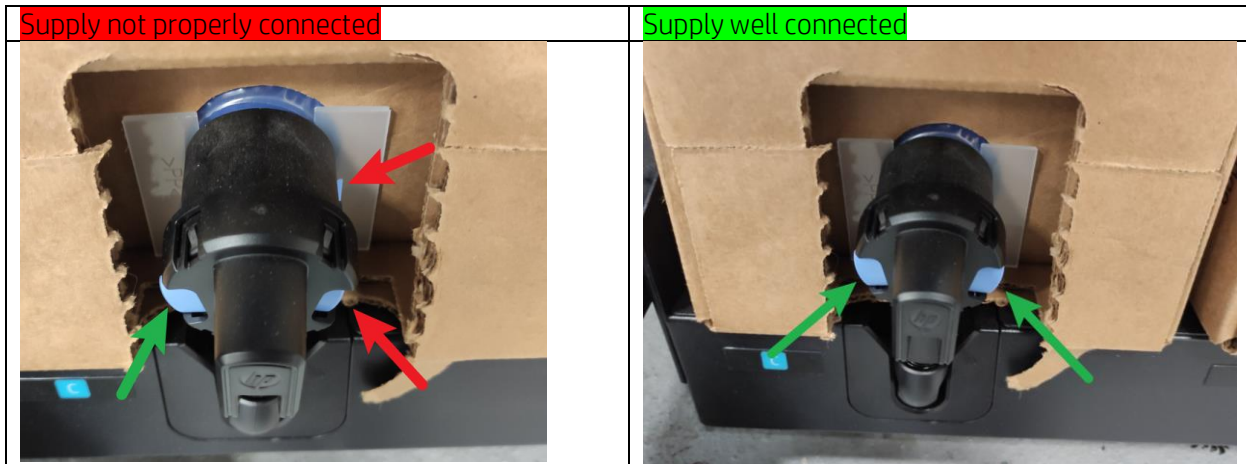
The supply ink connector has two blue levers. These levers should be latched to the 3L supply, otherwise the printer will report "Supply not Connected".

Check that the supply ink connector is properly inserted.

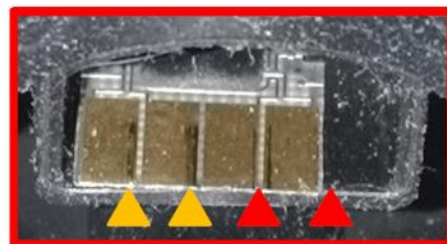
See the following example of a misplaced chip. As a result, the connector is unable to contact and therefore communicate with the acumen.

Chip installed off-center

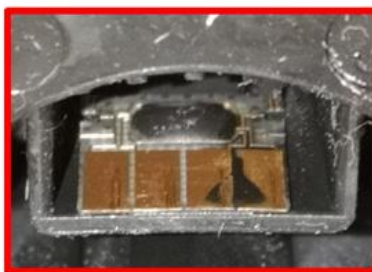
The following images show examples of dirty acumen. In all cases they need to be cleaned.

Ink on and between pads

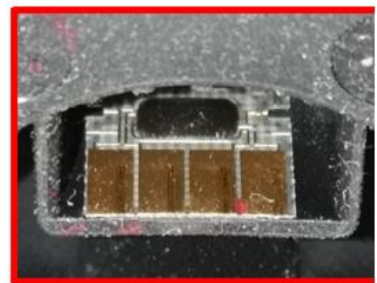
Ink between pads

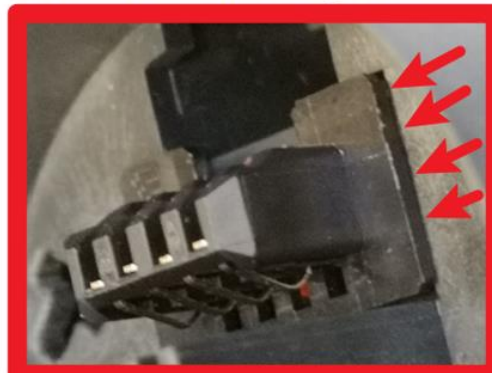
New connector not fitting on frame

- a. Check the connector base is aligned with the housing

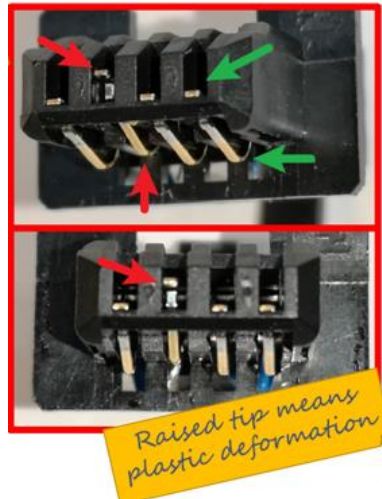
New connector bent in

- b. Check the acumen connector pins are not bent or broken
