For the HP Latex 700 / 800 printer series

November 2022

A new firmware version PLS_33_22_39.1 is now available to download and install for the HP Latex 700 and 800 printer series. HP strongly recommends installing this new firmware version on all units, as it includes significant improvements. Please note this replaces the previous version PLS_32_22_23.7.

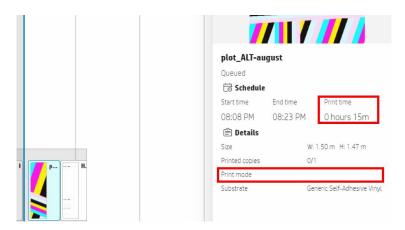
Queued jobs (up next) from front panel reprints do not have the correct job duration estimation. The print time is indicated as 15 minutes by default and the print mode information is missing. This will be fixed in the next firmware release.

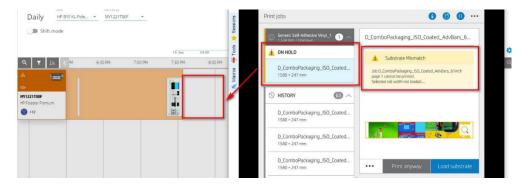
• When the media is loaded and the media configured on printer have a size mismatch, the jobs remain on hold in the front panel and do not appear in live production:

When the media size is set to the correct one, the jobs appear in live production in queue and printing:

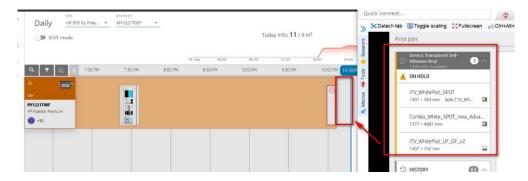
When there is an error, and the printer stops to print (any system error, any of the printer windows/doors are open, etc.). The job status changes to 'on hold' again and do not appear.

When the issue is resolved, the user must manually move jobs from on hold (release) to printing queue, and the jobs will appear in live production again.

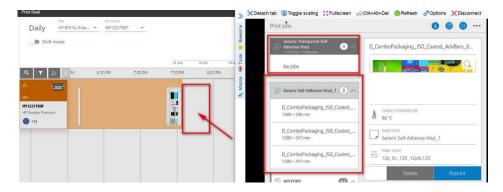
When there is a different type of media configured for the jobs than that configured in the printer, the jobs stay paused. This state is similar to on hold status and does not appear in production.

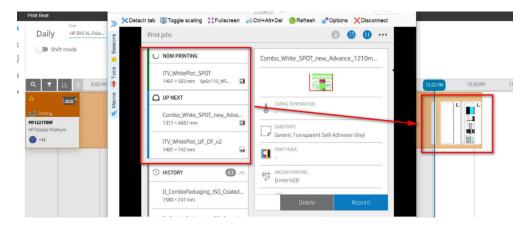
Additionally, the user can manually pause the jobs.

When the correct media is set, the jobs appear in live production in the queue and printing.
