Firmware SKAAR_21_21_36.13

For the HP Latex R Printer Series

March 2023

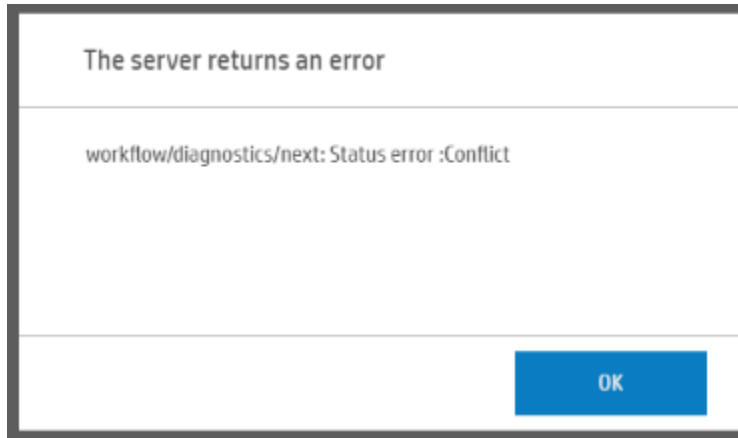
- A fix for the assert error 81A6-7ACE-0000 after you cancel a print job under certain circumstances. Already in MR6 but is now able to cover more conditions.
- A condition has been fixed where some maintenances might show a generic name "STR_MaintenanceTitle". With this release the IPS software is able to detect this condition and schedule an update for the next synchronization with the server. This synchronization can be forced by restarting the IPS PC .
- A random issue was fixed when trying to run a diagnostic in diagnostic boot mode. "workflow/diagnostic/next: Status error :Conflict"

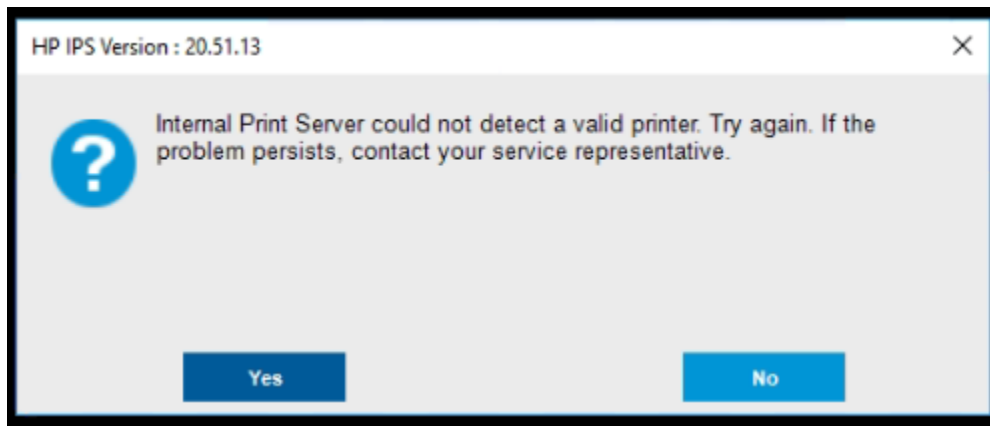
- During the first IPS application boot after upgrading the IPS software, a message as shown below may appear indicating that no valid printer is detected. If this message appears, the application will not open.

This usually means that the communication with the printer is not working as expected. There are several possible causes:

- Printer disconnected
- Printer with a severe error
- Printer with a firmware lower than MR6
- Temporal disconnection between printer IPS and printer

The fix included in this software release will allow you to boot the IPS application up, even the communication fails, allowing you then to troubleshoot the communication issue.
