New firmware release SKAAR_22_23_37.6

For the HP Latex R-Series printer series

July 2024

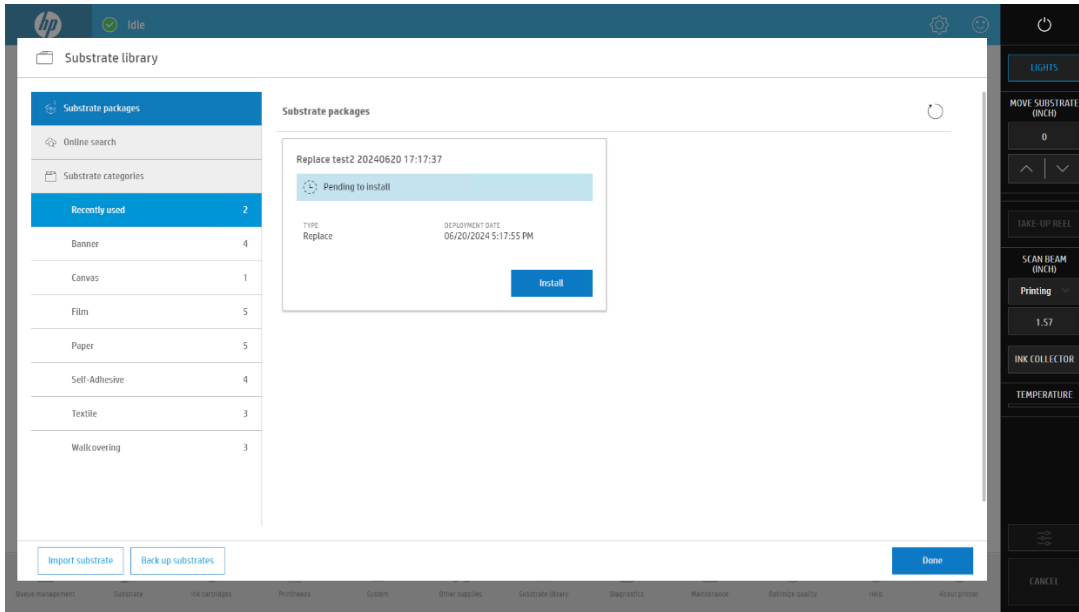
- **Restoring substrates packages from configuration center**

Occasionally, when attempting to replace the substrate packages using the backup from the Configuration Center, an error may occur in the process.

1. Generate a Replace package in Configuration Center.
2. Download and try to Install the Replace package from the IPS front panel.

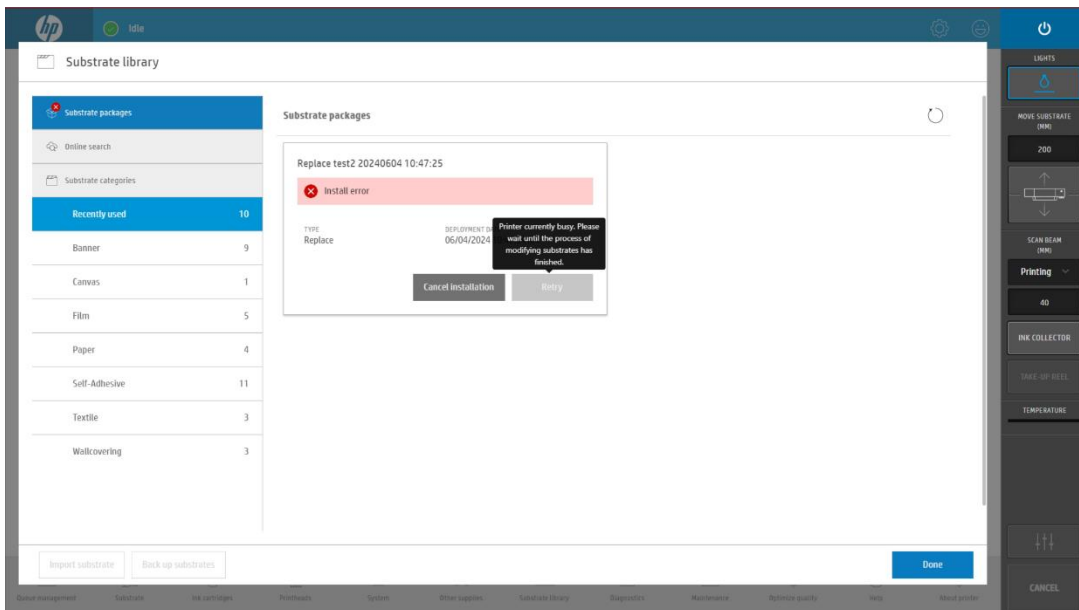
3. The Backup is done, but the "Option not available. During ..." error is displayed.
4. Tap on the Retry button to try to install the Replace package again.

5. A few moments later, the "Substrate package XXX failed ..." error is displayed.
6. Tap on the Retry button again.

7. The Custom Medias are deleted, but the Replace package is in "Installing" status and the "Receiving" status is constantly displayed in the right bar.

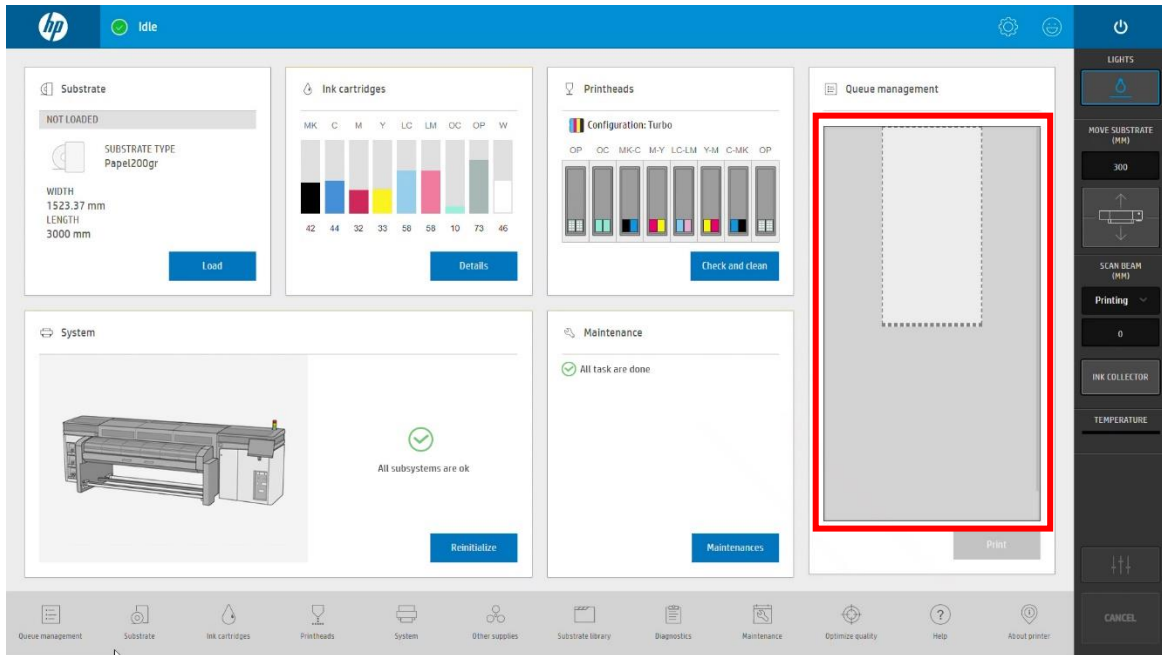
- **Queue management preview may show media moving**

The queue management preview might show a random bug where the image glitches for one second moving a little to one side before going back to normal. This happens randomly and does not affect the behavior of the application. It can happen in the main view of the IPS or in the Queue management window.
