New firmware release MR3 is available

For HP Stitch S1000 126i Printer Series

November 2020

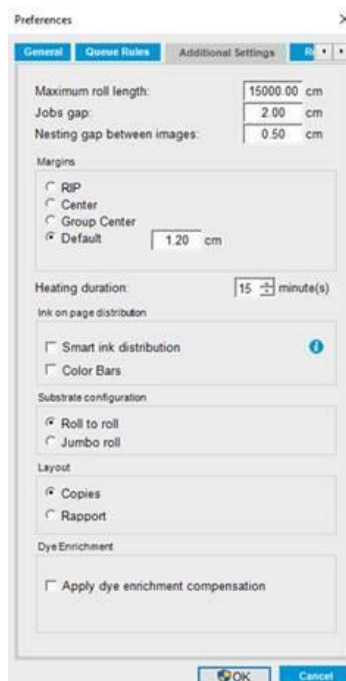
- Changed min. substrate width for printhead verification plot to 42 inches.
- Dye Enrichment Compensation (needs to be activated in IPS):

Dye Enrichment is an ink-related defect that gradually appears after a short idle period (>1sec). An increased colorant density in individual drops is observed and the image on the substrate appears darker.

This defect decreases quickly after few centimeters of printing. The Dye Enrichment Correction functionality is able to mitigate this local defect and improve the final printing quality.

TIP: Spit Bars could also be used to reduce the idle time for all colors, and as such, using Spit Bars will help to reduce the Dye Enrichment effect.
