Firmware PLS_31_22_14.6 is available

For the HP Latex 700 / 800 printer series

June 2022

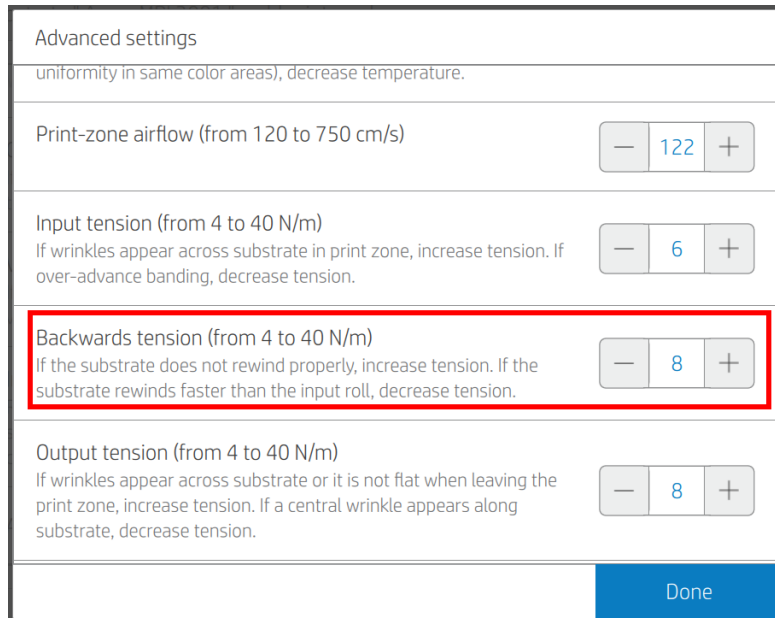
Backwards input tension

Tension applied by the input roll when the substrate moves backwards. It can be accessed from **Control Panel > Substrate Library > My substrate > Edit print mode > Advanced settings > Backwards tension**

Increase, in steps of 5 N/m up to 30N/m if the substrate is slipping or does not advance at **all when doing backward movements.**

Decrease, in steps of 5N/m down to 4 N/m, when the input roll advances too much when moving the substrate backwards. This happens most often with films.

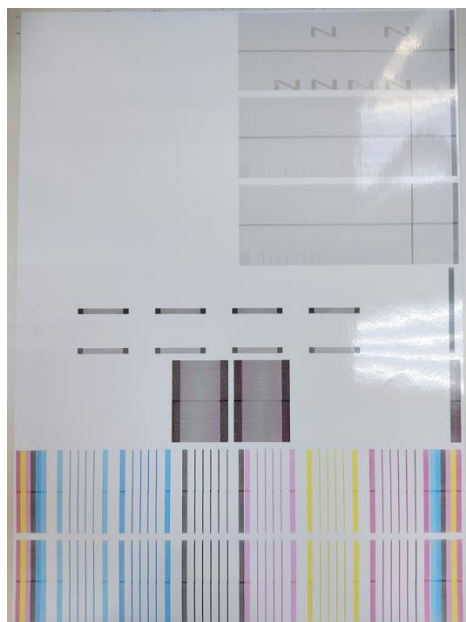
- **Automatic printhead alignment**

New APA plot, that improve the automatic printhead alignment, which is now the recommended option.

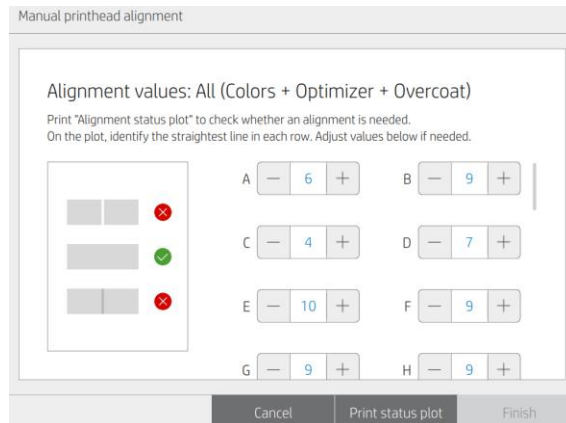
- **Manual printhead alignment**

You can now change the calibration values of the Manual Printhead Alignment calibration without printing the calibration plot.
