# Firmware PLS\_40\_22\_52.1 is available

For the HP Latex 700 / 800 printer series

February 2023

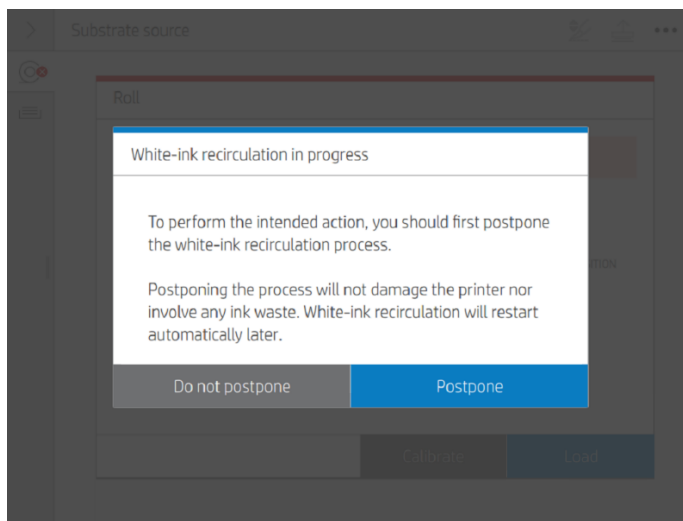
The recirculation itself will also be automatically cancelled if the end-user triggers any action that blocks the self-maintenance process (new message and workflow).

This message will be shown with any action that requires the cancellation of this routine such as media loading and unloading, cutting, etc.

With this new firmware release the white ink delivery recirculation process can be cancelled. This improves the response time considerably in case any urgent action needs to be performed in the middle of the self-maintenance routine.

The cancel process could take up to 6 minutes but on average approximately 2 minutes, similar to the rest of the calibrations (CLC, ICC, check and clean, PH alignment, nozzle health, etc.) that will now take approximately 2 minutes to be cancelled.

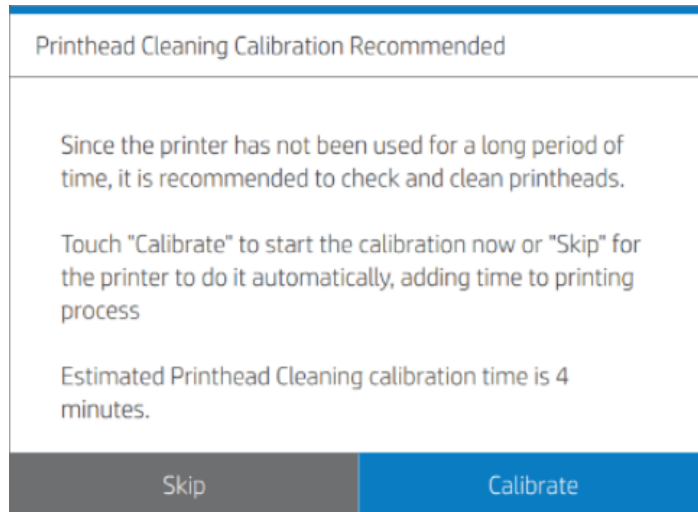
A new recommendation message will pop up to advise for a checking and cleaning calibration, if the printer has not been used for over 3 days. It will be shown after turning the printer on and when it wakes up.

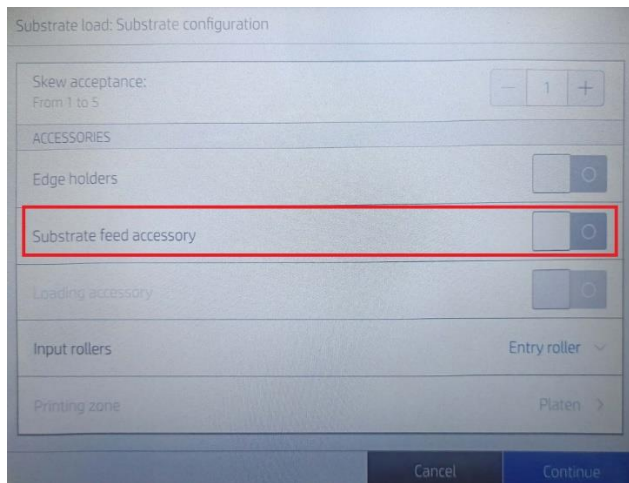
Furthermore, the new firmware includes a new media saver setting. By enabling it while the substrate is being loaded, the curtain opens to allow the leading edge and media saver to pass.
