# New firmware release

## PLS\_42\_23\_24.1

For the HP Latex 700 / 800 printer series

June 2023

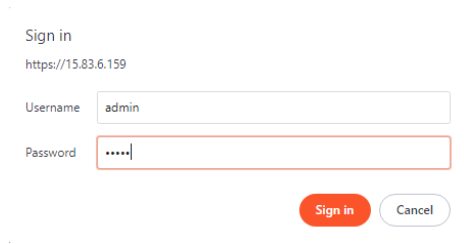
**NOTE:** You might be required to enter user and password details. Type **admin** in each field and tap **Login**.

Sign in  
https://15.83.6.159

Username

Password

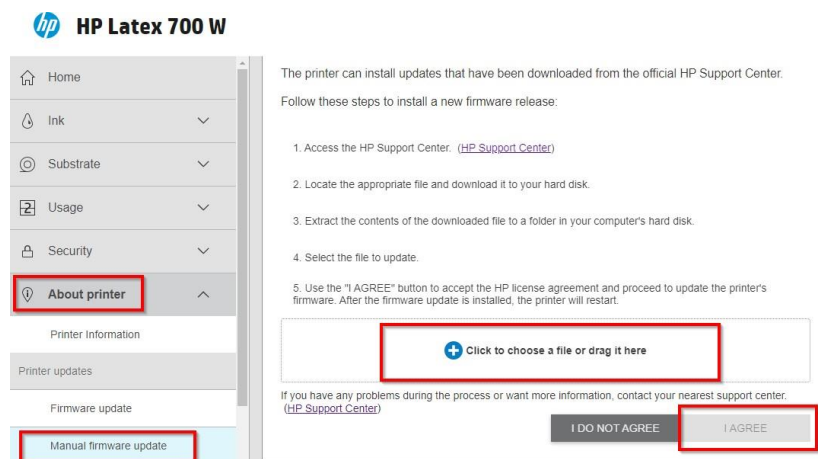
3. In the Embedded Web Server, select **Information** and then **Firmware update > Manual firmware update**.

**hp HP Latex 700 W**

Home  
Ink  
Substrate  
Usage  
Security  
**About printer**

Printer Information  
Printer updates  
Firmware update  
**Manual firmware update**

4. Browse to select the downloaded .fmw file and click **Agree**.
5. The printer will reboot itself when the FW upgrade is completed.

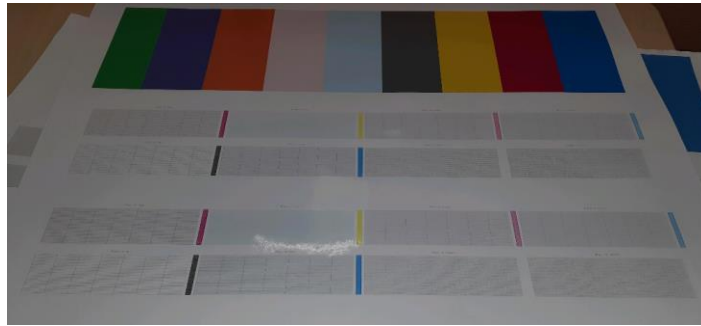
In this FW, the image to be printed as nozzle health plot is changed to avoid misunderstandings.

- The warmups printed in the media will not be longer there, it will be spitted on the maintenance cartridge.
- The firing frequency of the spit bars just after printing the nozzle map is increased to minimize print quality issues that could be misunderstood while evaluating the plot.

Find below picture with the latest changes:
