New firmware release

SKAAR_22_23_37.2

For the HP Latex R-Series printer series

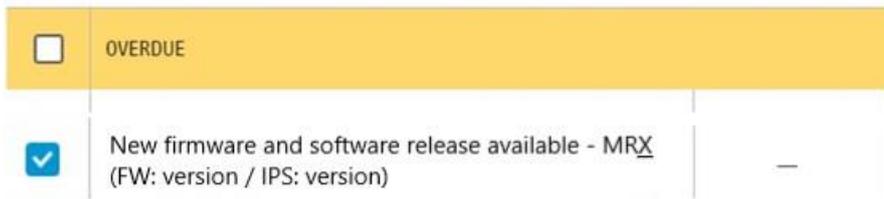
If the installation is done from the previous 3 versions, a maintenance alert will appear in the IPS warning of the new firmware. The maintenance is localized to the languages that the printer supports.

By entering the maintenance, a list of improvements will be displayed with two buttons, **Install Firmware** and **Install IPS**. Upgrade the firmware first and then the IPS.

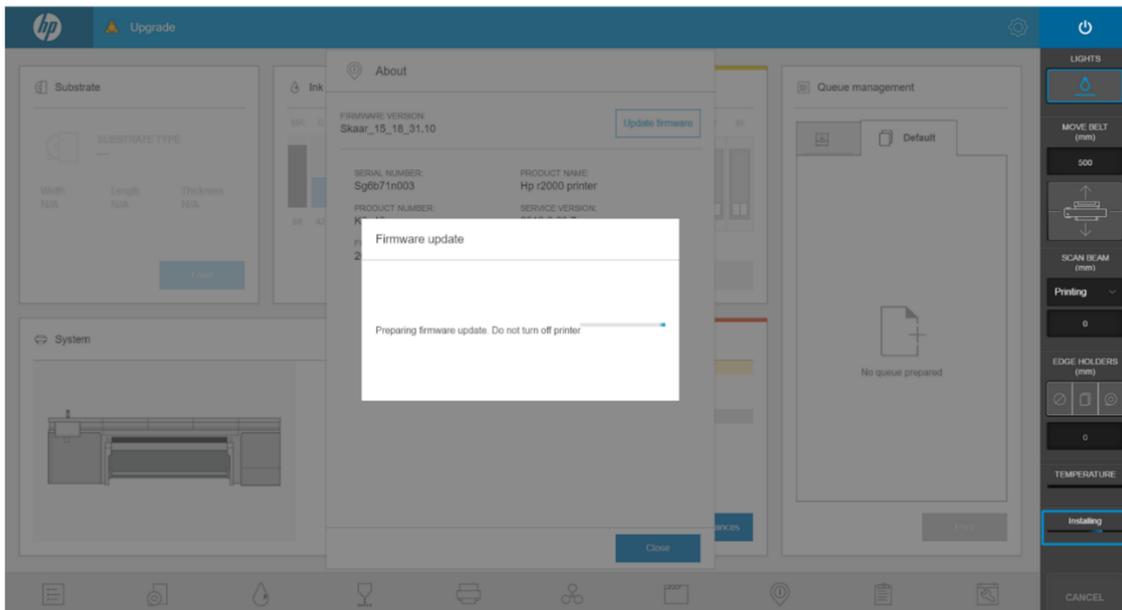
3. The firmware will be uploaded and installed on the printer. The status of the update can be checked on the right-hand side of the IPS main window. There are two possible statuses: **Receiving** and **Installing**.

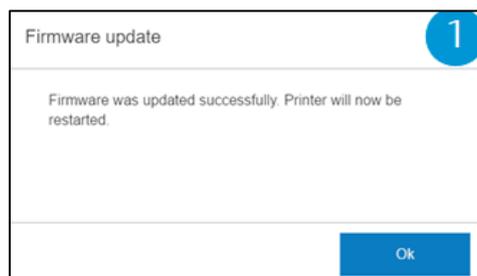
- Upon completion, the IPS will show the following message. Tap **Ok** to continue. At this point, the printer will automatically reboot. If it does not, reboot the printer manually.

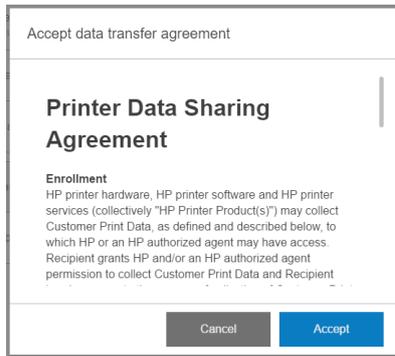
6. On the first boot, the Printer Data Sharing Agreement (PDSA) window will appear. Please click **Accept** to continue.

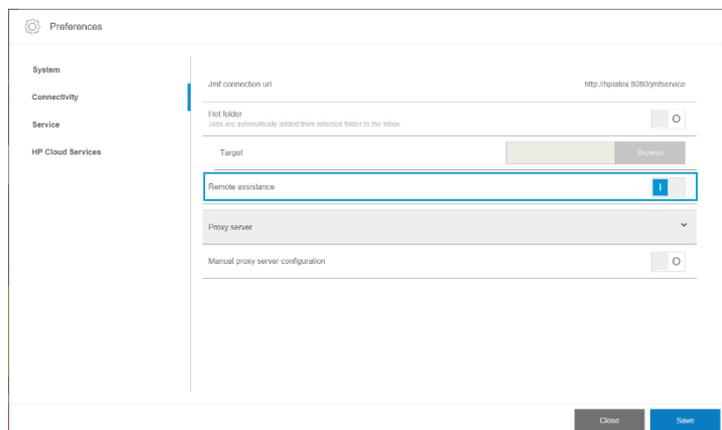
Finally, you need to ensure that the **Remote assistance** option is enabled in the IPS Preferences window so that the system can send printer information to the HP servers. Note that this option will be enabled by default if the PDSA has been accepted when installing the new Internal Print Server.

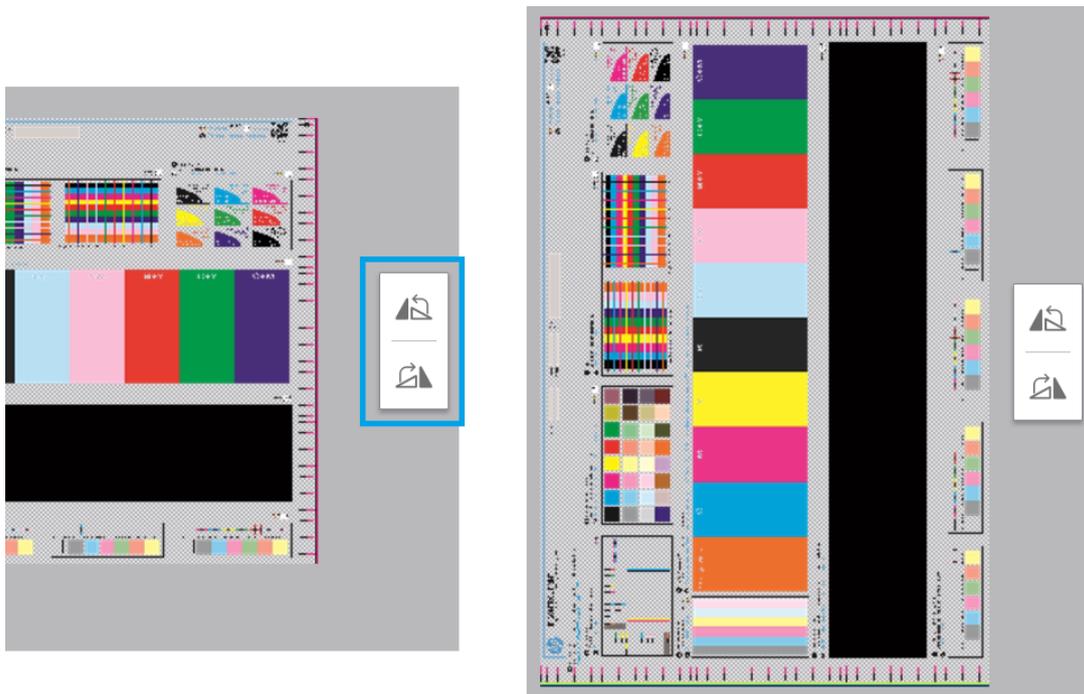
It is possible to rotate individual job on the IPS to avoid the need of re-ripping it.

IMPORTANT: Once the job has visually rotated and it is in the queue, it will take a few moments before it can be printed (the print button will be grey until ready).

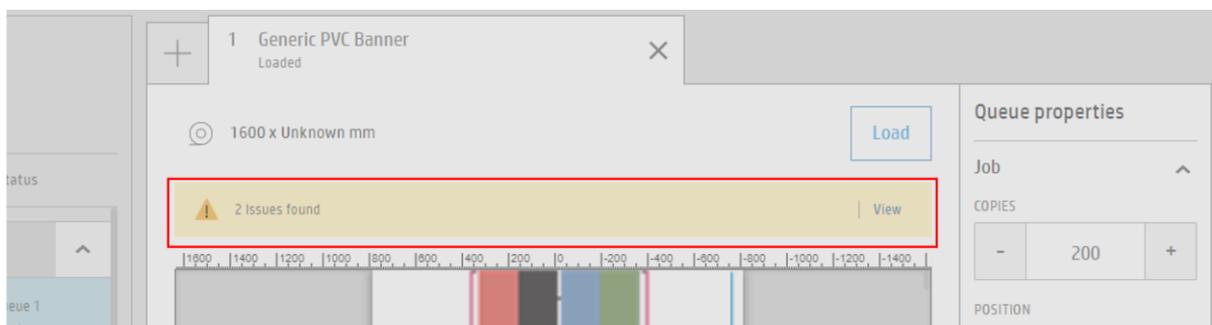
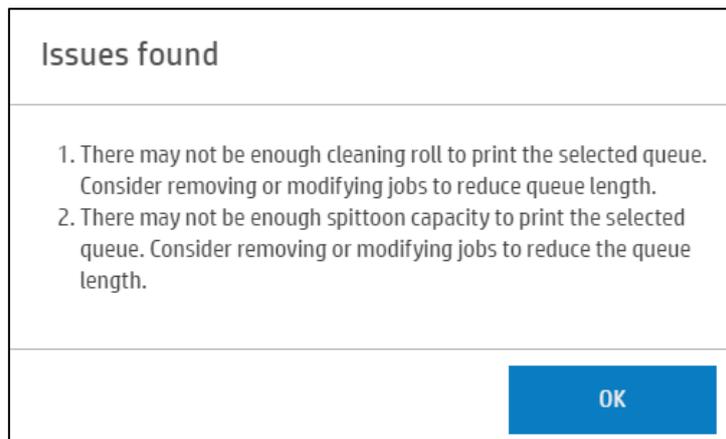
When adding a job in the jobs queue, the IPS will inform customers if there is enough web wipe roll and left Spittoon capacity to complete the selected jobs. The following error message is displayed if there is not enough cleaning roll or left Spittoon to complete the queue:

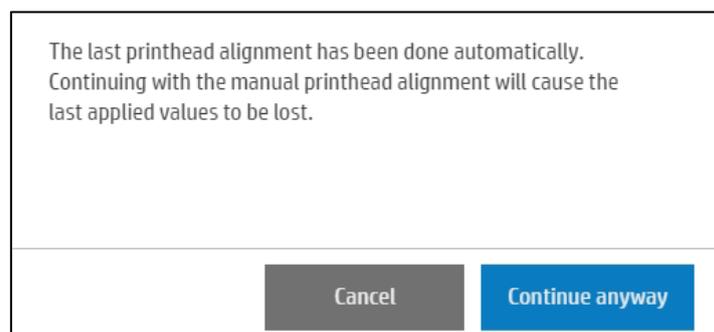
In case the printer uses currently an automatic printhead alignment and user tries to modify a manual alignment value, a warning will be showed. This will be useful to understand if printer currently uses an automatic or manual calibration.

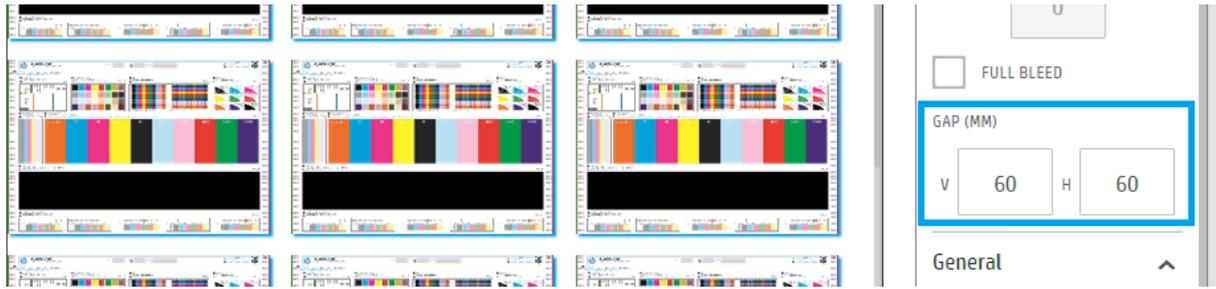
A new setting at queue level allows to add a vertical or horizontal gap between jobs and copies.

NOTE: This gap doesn't apply the margin left between a job and the end of the media. This gap is only applied between copies.

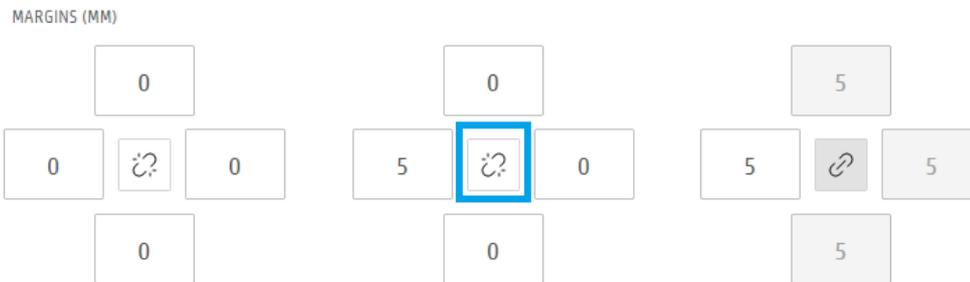
Enabling the lock allows to change all four margins in a single step at queue level:

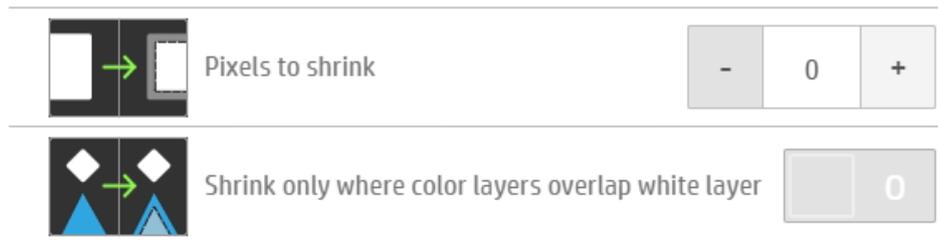
Choke white ink
Shrink white layer edge

The functionality is enabled in case "Pixels to shrink" is different than zero.

Diagram illustrating the 'Choke white ink' functionality. The first row shows a white rectangle being shrunk by a specified number of pixels, with a control for 'Pixels to shrink' (set to 0) and minus/plus buttons. The second row shows a diagram where the white layer is shrunk only where it overlaps with other color layers, with a corresponding toggle switch (set to 0).

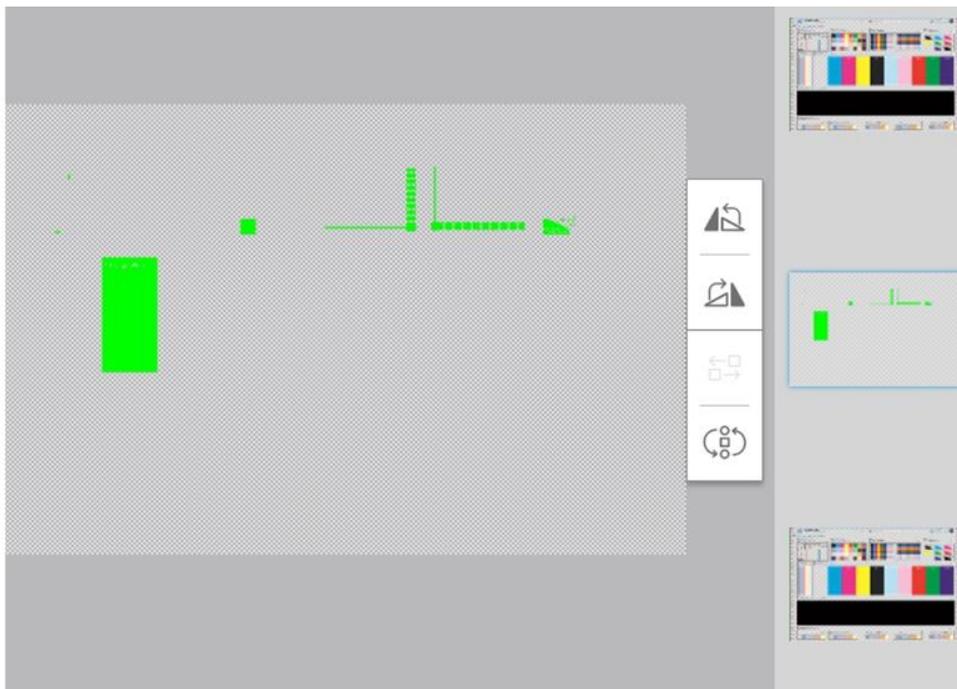
White job preview is showed in bright green gradient (white) over transparent (non-white):

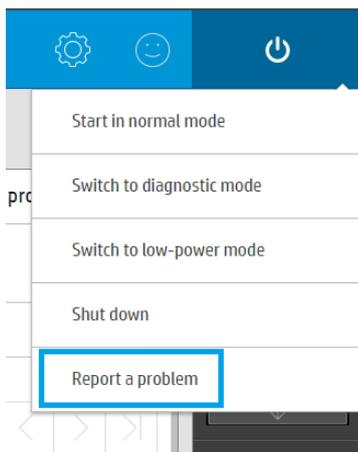
The button "Report a problem" creates a diagnostic package as getLogs.exe does. This allows to save the result in an external USB device or in the internal IPS Hard Drive, the IPS will ask to select the specific folder. This diagnostic package is used to better understand printer issues and help solve them.

NOTE: This button doesn't create an incidence, it just creates the diagnostic package.

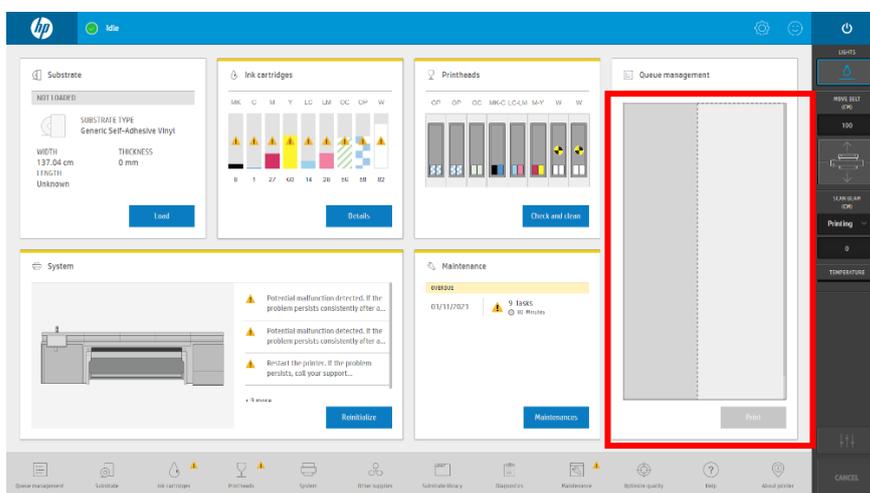
- In the Internal Print Server (IPS), the queue management preview might show a random bug where the image glitches for one second moving a little to one side and goes back to normal. This happens randomly and not very often. The issue doesn't affect the behavior of the application. It can happen in the main view of the IPS or in the Queue management window.
